INSTALLATION AND OPERATING INSTRUCTIONS

6-PAK CAUTION AND WARNING LABELS

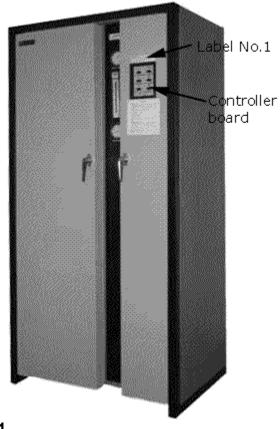
Figure 1

1. Refer to Figure 1, peel the back from **Label No. 1** and place it in the correct location (below controller board front door).

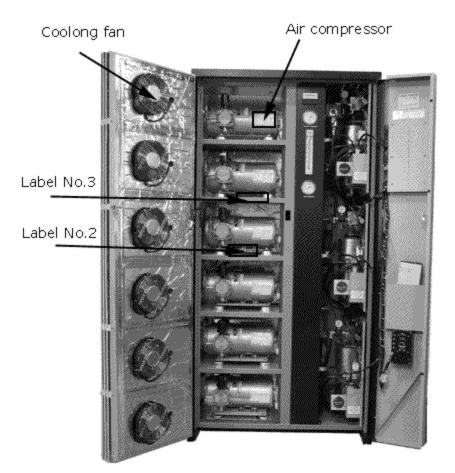
Figure 2

2. Refer to Figure 2, peel the back from **Label No. 2** and place it in the correct location (flat on third compressor shelf).
3. Refer to Figure 2, peel the back from **Label No. 3** and place it in the correct location (front on fourth compressor shelf).
